## **Earba Pumped Storage Hydro Scheme EIA Report**

### **Appendix 12.3: Schedule of Watercourse Crossings**

**February 2024**

## Technical Appendix 12.3: Schedule of Watercourse Crossings

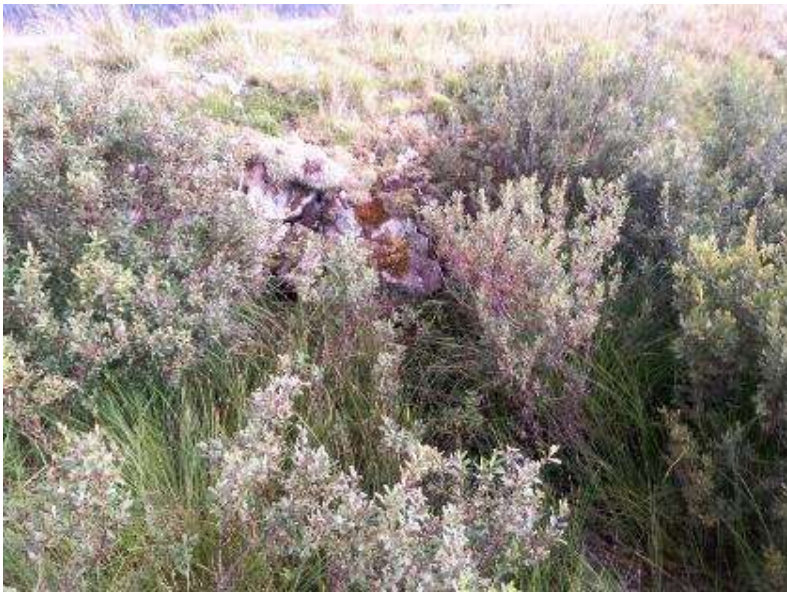
| Watercourse Crossing ID | WX01 |
|---|---|
| Watercourse Crossing Details | <p><b>NGR:</b> NN 44075 82114</p> <p><b>Status:</b> Existing</p> <p><b>Culvert Diameter:</b> 0.8 m</p> <p><b>Culvert Construction Type:</b> Concrete, circular culvert.</p> <p><b>Watercourse Width:</b> 0.8 - 1.2 m</p> <p><b>Watercourse Depth:</b> 0.1 – 0.8 m</p> <p><b>Notes:</b> Culvert half submerged on upstream entrance. Heavily vegetated</p> |
| Photograph of Culvert Entrance from Upstream | A photograph showing the upstream entrance of a culvert. The area is heavily overgrown with dense, tall grasses and various shrubs, making the entrance difficult to see. The culvert itself is partially submerged in the water. |

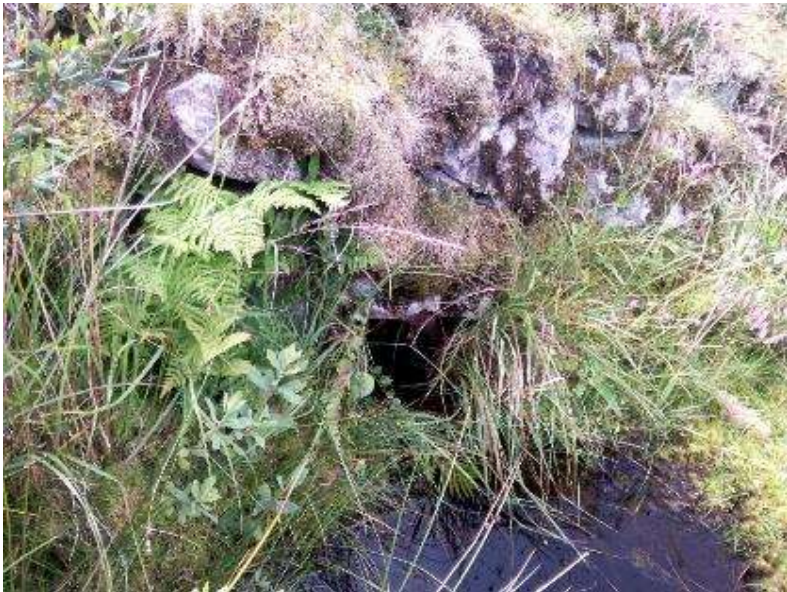
| Watercourse Crossing ID | WX01 |
|---|---|
| Photograph Looking at Culvert Exit from Downstream | A photograph showing the downstream exit of a culvert. The culvert is partially submerged in the water, and the surrounding area is heavily vegetated with tall grasses and ferns. The water is dark and still. |

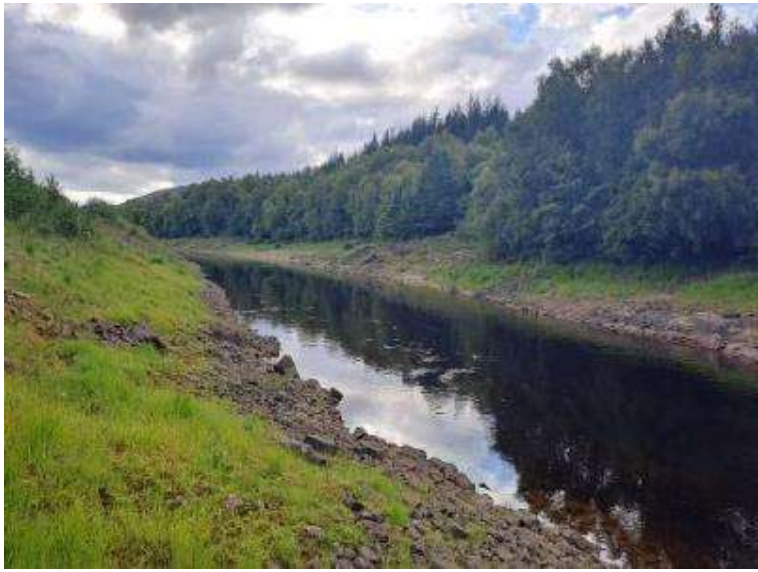
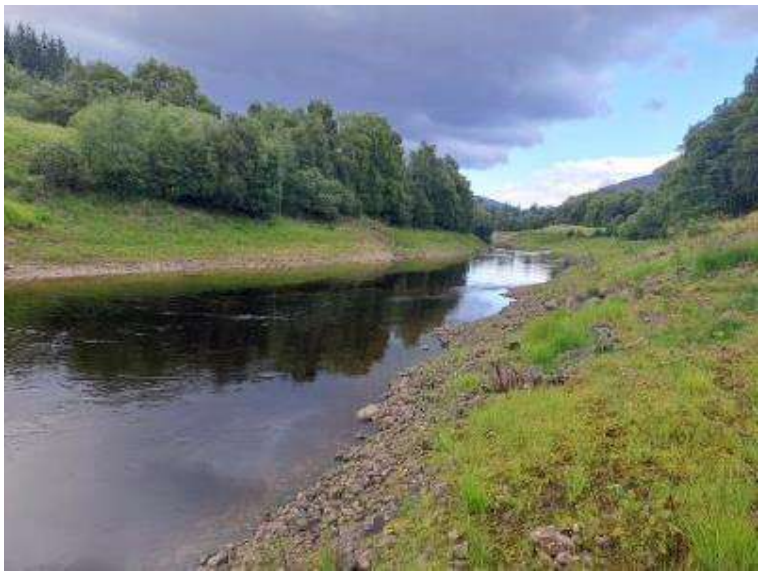
| Watercourse Crossing ID | WX02 |

| Watercourse Crossing ID | WX02 |
|---|---|
| Watercourse Crossing Details | <p><b>NGR:</b> NN 43548 83089</p> <p><b>Status:</b> New</p> <p><b>Watercourse Width:</b> 6 - 8 m</p> <p><b>Watercourse Depth:</b> 1 m</p> <p><b>Notes:</b> None.</p> |
| Photograph Looking Upstream | |
| Photograph Looking Downstream | |

| Watercourse Crossing ID | WX02 |
|---|---|
| Proposed Crossing Type<br>Likely Required CAR<br>Authorisation | <p>Open Span Bridge<br/>Licence</p> |

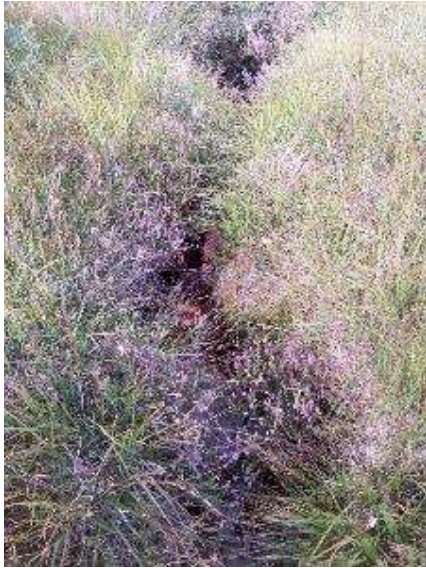
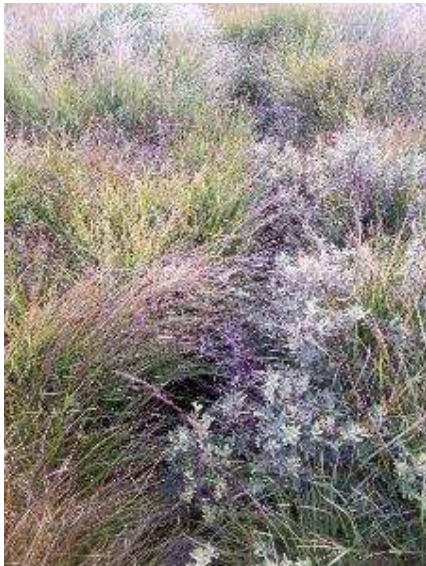
| Watercourse Crossing ID | WX03 |
|---|---|
| Watercourse Crossing Details | <p><b>NGR:</b> NN 44780 81797</p> <p><b>Status:</b> New</p> <p><b>Watercourse Width:</b> 0.5 m</p> <p><b>Watercourse Depth:</b> 0.2 m</p> <p><b>Notes:</b> Watercourse surveyed 20m downstream of the proposed crossing point. Watercourse sits within channel 0.5m deep.</p> |
| Photograph Looking Upstream | |
| Photograph Looking Downstream | |

| Watercourse Crossing ID | WX03 |
|---|---|
| Proposed Crossing Type<br>Likely Required CAR Authorisation | <p>Culvert<br/>Registration</p> |

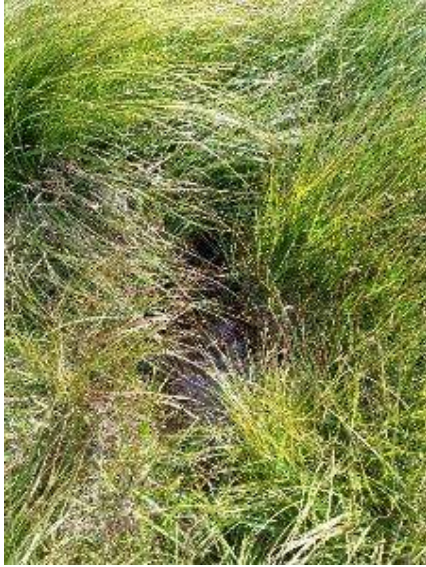
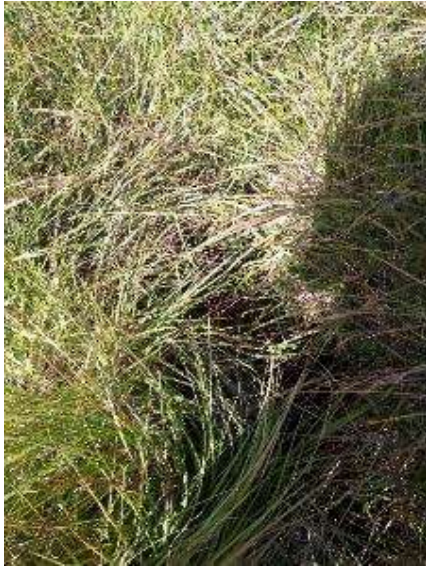
| Watercourse Crossing ID | WX04 |

| Watercourse Crossing ID | WX04 |
|---|---|
| Watercourse Crossing Details | <p><b>NGR:</b> NN 45157 81401</p> <p><b>Status:</b> New</p> <p><b>Watercourse Width:</b> 0.4 m</p> <p><b>Watercourse Depth:</b> 0.3 m</p> <p><b>Notes:</b> Watercourse sits within channel 1m deep which is heavily vegetated.</p> |
| Photograph Looking Upstream | |
| Photograph Looking Downstream | |

| Watercourse Crossing ID | WX04 |
|---|---|
| Proposed Crossing Type<br>Likely Required CAR Authorisation | <p>Culvert<br/>Registration</p> |

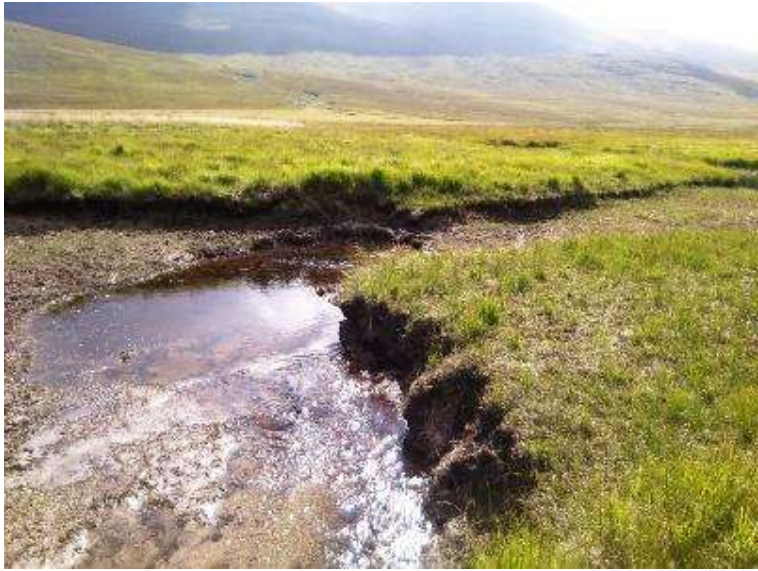
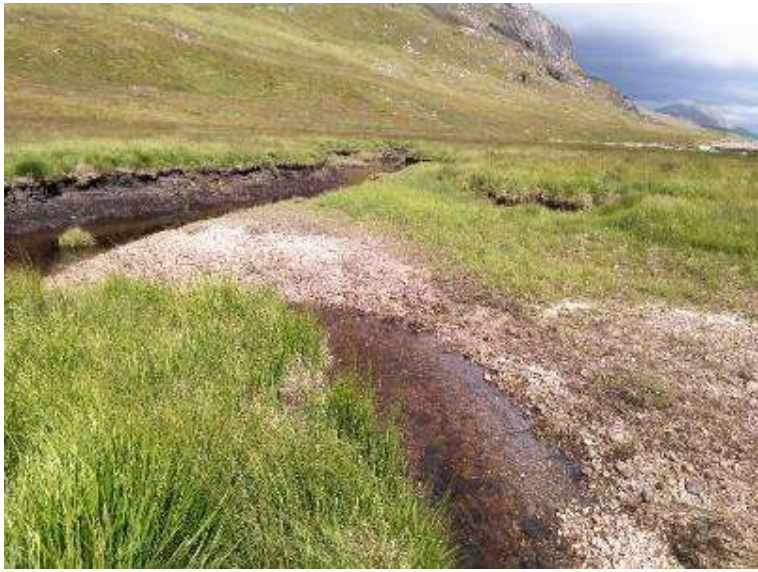
| Watercourse Crossing ID | WX06 |

| Watercourse Crossing ID | WX06 |
|---|---|
| Watercourse Crossing Details | <p><b>NGR:</b> NN 46204 81279</p> <p><b>Status:</b> New</p> <p><b>Watercourse Width:</b> 1 – 1.5 m</p> <p><b>Watercourse Depth:</b> 0.2 m</p> <p><b>Notes:</b> Watercourse situated within peat hags up to 1.2 m high.</p> |
| Photograph Looking Upstream | |
| Photograph Looking Downstream | |

| Watercourse Crossing ID | WX06 |
|---|---|
| Proposed Crossing Type<br>Likely Required CAR<br>Authorisation | <p>Bottomless arch culvert or bridge<br/>Registration</p> |

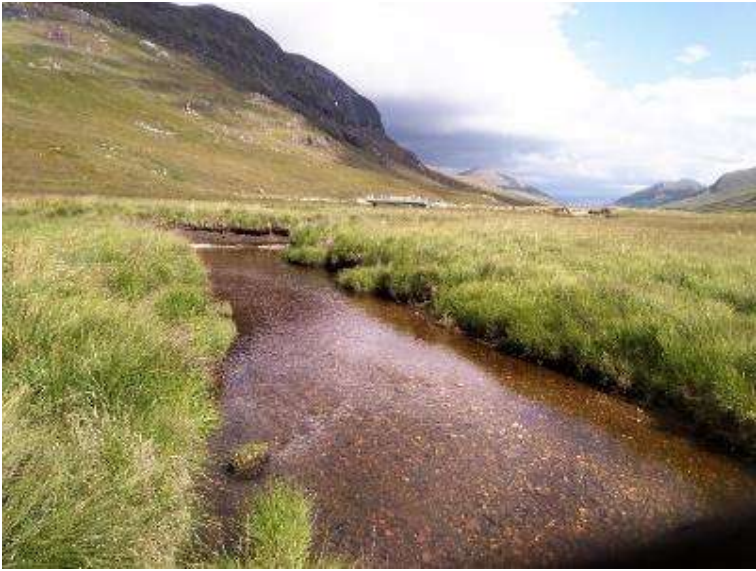
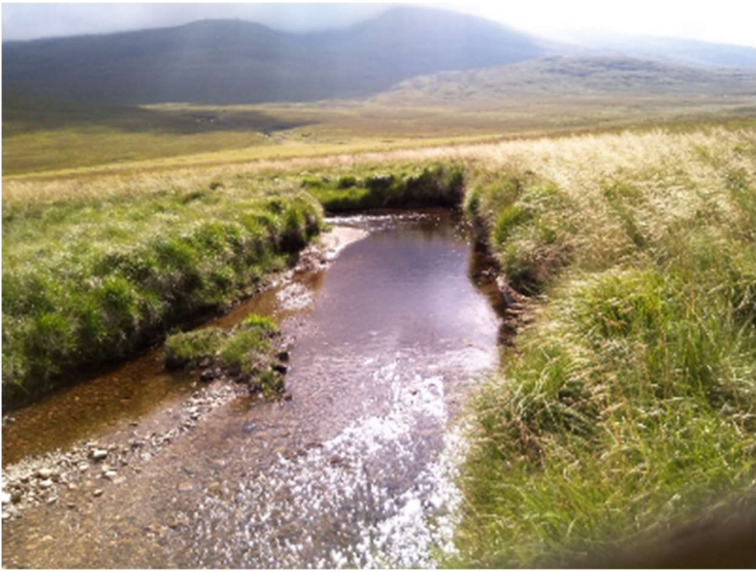
| Watercourse Crossing ID | WX07 |

| Watercourse Crossing ID | WX07 |
|---|---|
| Watercourse Crossing Details | <p><b>NGR:</b> NN 4623781249</p> <p><b>Status:</b> New</p> <p><b>Watercourse Width:</b> 4 m</p> <p><b>Watercourse Depth:</b> 0.1 - 0.2 m</p> <p><b>Notes:</b> Watercourse situated within peat hags up to 1 m high.</p> |
| Photograph Looking Upstream | |
| Photograph Looking Downstream | |

| Watercourse Crossing ID | WX07 |
|---|---|
| Proposed Crossing Type<br>Likely Required CAR<br>Authorisation | <p>Bottomless arch culvert or bridge<br/>Licence</p> |

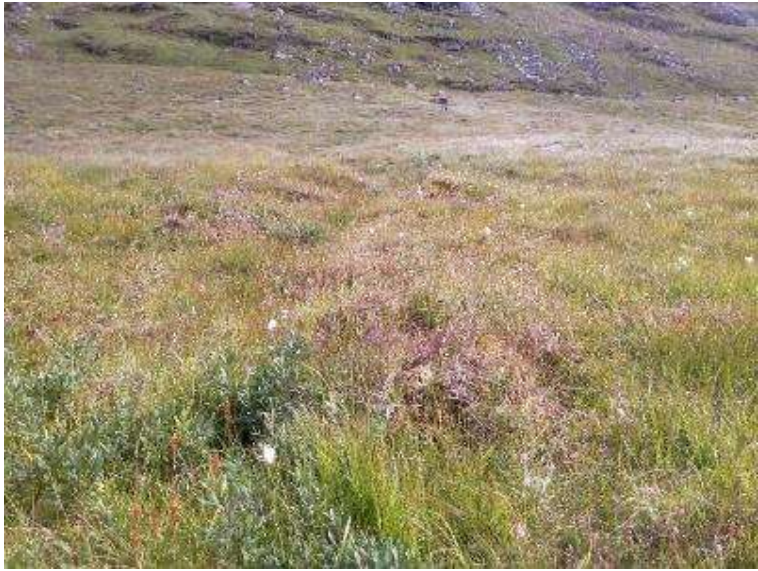
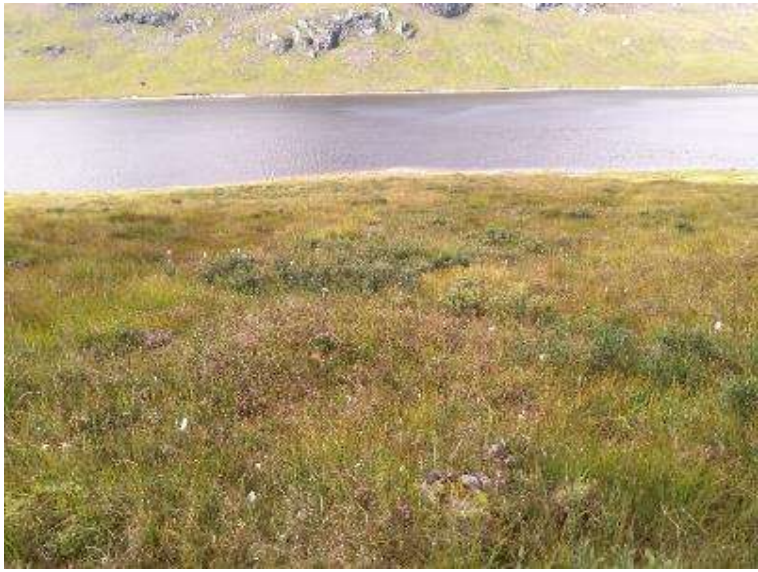
| Watercourse Crossing ID | WX08 |

| Watercourse Crossing ID | WX08 |
|---|---|
| Watercourse Crossing Details | <p><b>NGR:</b> NN 47268 81649</p> <p><b>Status:</b> New</p> <p><b>Watercourse Width:</b> 0.1 m</p> <p><b>Watercourse Depth:</b> 0.1 m</p> <p><b>Notes:</b> Very low flow.</p> |
| Photograph Looking Upstream | |
| Photograph Looking Downstream | |

| Watercourse Crossing ID | WX08 |
|---|---|
| Proposed Crossing Type<br>Likely Required CAR<br>Authorisation | <p>Culvert<br/>Registration</p> |

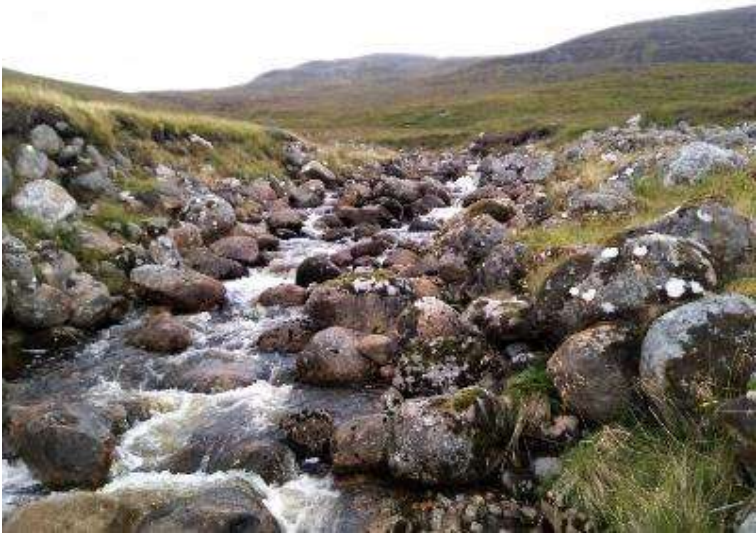
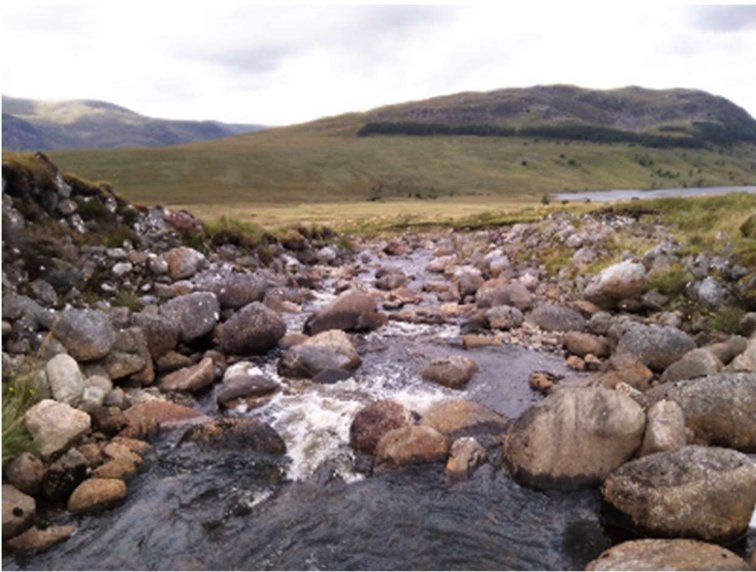
| Watercourse Crossing ID | WX09 |
|---|---|
| Watercourse Crossing Details | <p><b>NGR:</b> NN 48836 83316</p> <p><b>Status:</b> New</p> <p><b>Watercourse Width:</b> 3 m</p> <p><b>Watercourse Depth:</b> 0.3 m</p> <p><b>Notes:</b> Watercourse situated within channel 2 to 3 m high.</p> |
| Photograph Looking Upstream | <p>A photograph showing a rocky watercourse flowing upstream. The water is turbulent as it flows over numerous large, dark, moss-covered rocks. The surrounding landscape is a grassy hillside under an overcast sky.</p> |
| Photograph Looking Downstream | <p>A photograph showing a rocky watercourse flowing downstream. The water is turbulent as it flows over numerous large, dark, moss-covered rocks. The surrounding landscape is a grassy hillside under an overcast sky.</p> |

| Watercourse Crossing ID | WX09 |
|---|---|
| Proposed Crossing Type<br>Likely Required CAR<br>Authorisation | <p>Bottomless arch culvert or bridge<br/>Licence</p> |

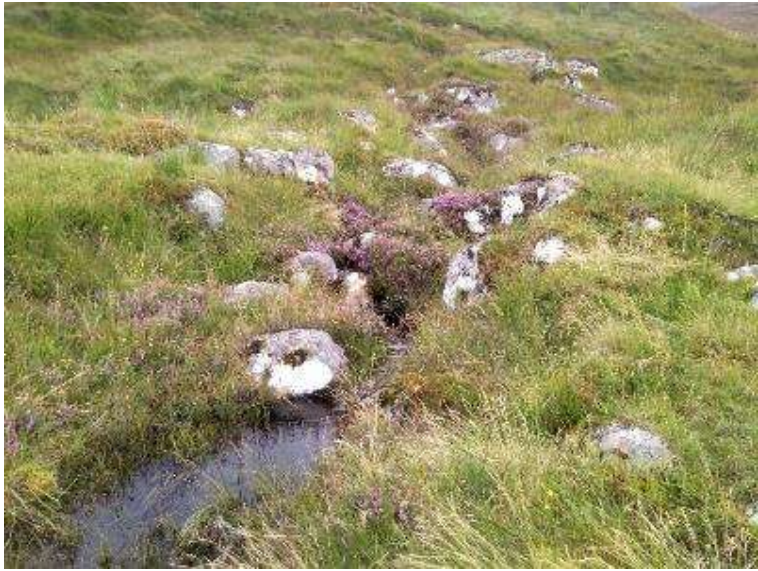
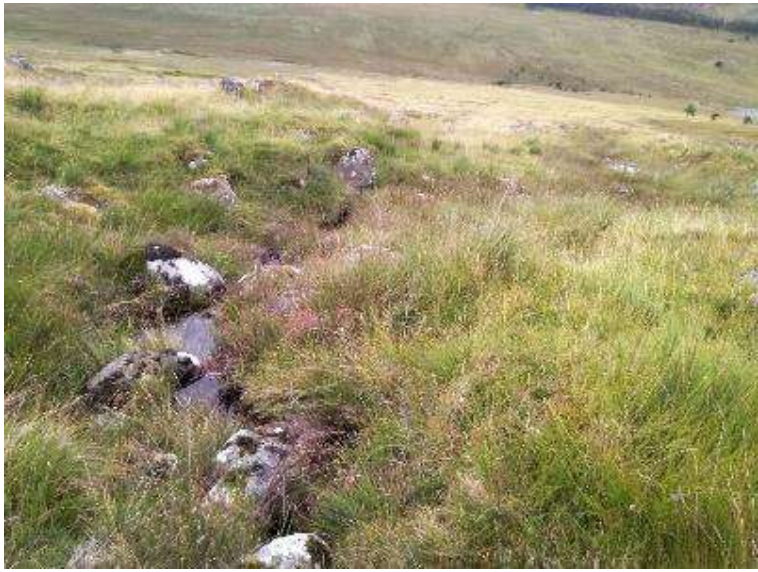
| Watercourse Crossing ID | WX10 |
|---|---|
| Watercourse Crossing Details | <p><b>NGR:</b> NN 48891 83374</p> <p><b>Status:</b> New</p> <p><b>Watercourse Width:</b> 0.5 m</p> <p><b>Watercourse Depth:</b> 0.1 m</p> <p><b>Notes:</b> None</p> |
| Photograph Looking Upstream | <p>A photograph showing a small, shallow watercourse flowing through a grassy field. The water is dark and still, reflecting the surrounding vegetation. The field is covered in green grass and some purple heather. Several large, light-colored rocks are scattered along the banks of the watercourse.</p> |
| Photograph Looking Downstream | <p>A photograph showing a small, shallow watercourse flowing through a grassy field. The water is dark and still, reflecting the surrounding vegetation. The field is covered in green grass and some purple heather. Several large, light-colored rocks are scattered along the banks of the watercourse.</p> |

| Watercourse Crossing ID | WX10 |
|---|---|
| Proposed Crossing Type<br>Likely Required CAR<br>Authorisation | <p>Culvert<br/>Registration</p> |

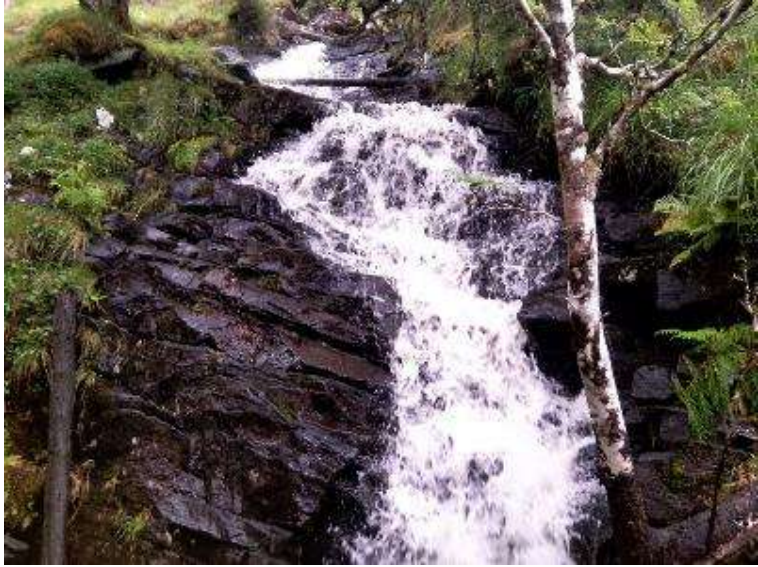
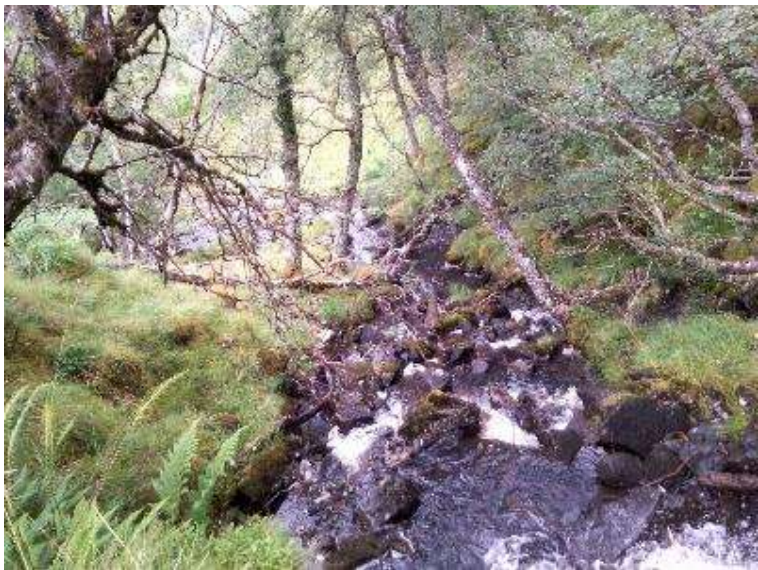
| Watercourse Crossing ID | WX11 |
|---|---|
| Watercourse Crossing Details | <p><b>NGR:</b> NN 49733 84406</p> <p><b>Status:</b> New</p> <p><b>Watercourse Width:</b> 1.5 m</p> <p><b>Watercourse Depth:</b> 0.1 – 0.3 m</p> <p><b>Notes:</b> Steep watercourse which is incised in bedrock.<br/>Watercourse situated within larger channel approximately 8 m high.</p> |
| Photograph Looking Upstream | |
| Photograph Looking Downstream | |

| Watercourse Crossing ID | WX11 |
|---|---|
| Proposed Crossing Type<br>Likely Required CAR<br>Authorisation | <p>Bottomless arch culvert or open span bridge<br/>Licence</p> |

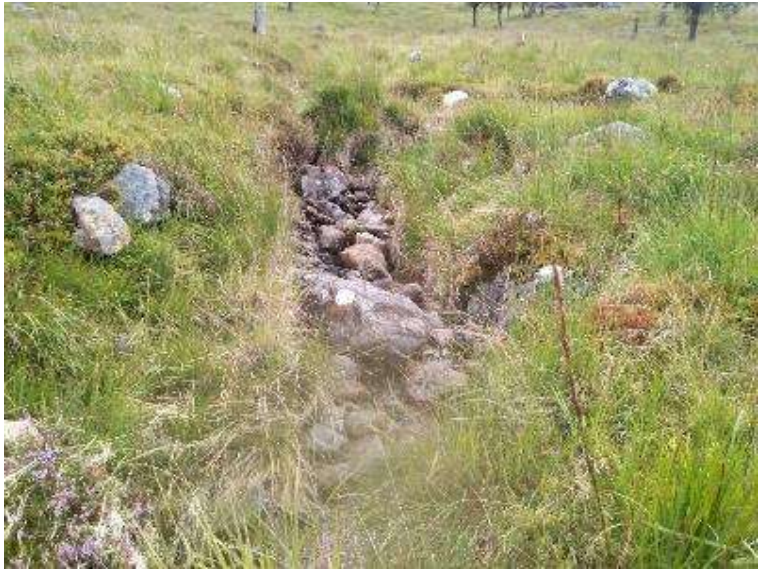
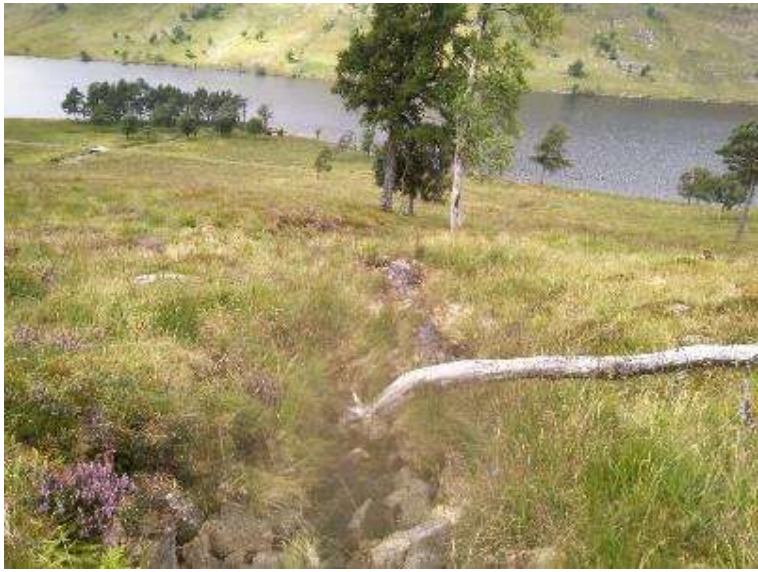
| Watercourse Crossing ID | WX12 |

| Watercourse Crossing ID | WX12 |
|---|---|
| Watercourse Crossing Details | <p><b>NGR:</b> NN 49745 84516</p> <p><b>Status:</b> New</p> <p><b>Watercourse Width:</b> 0.5 m</p> <p><b>Watercourse Depth:</b> 0.1 m</p> <p><b>Notes:</b> Watercourse situated within channel up to 0.5 m high.</p> |
| Photograph Looking Upstream | |
| Photograph Looking Downstream | |

| Watercourse Crossing ID | WX12 |
|---|---|
| Proposed Crossing Type<br>Likely Required CAR<br>Authorisation | <p>Culvert<br/>Registration</p> |

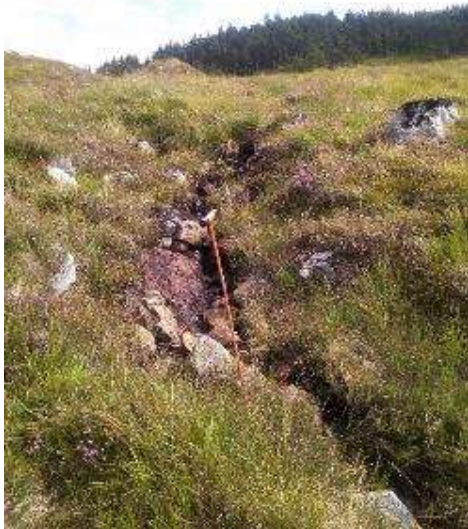
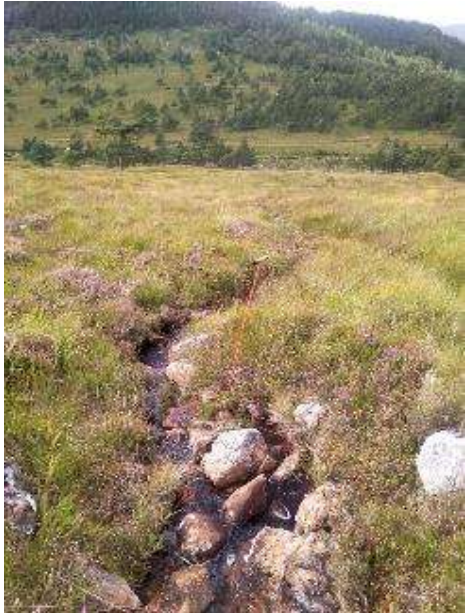
| Watercourse Crossing ID | WX13 |
|---|---|
| Watercourse Crossing Details | <p><b>NGR:</b> NN 50338 85836</p> <p><b>Status:</b> New</p> <p><b>Watercourse Width:</b> 0.6 m</p> <p><b>Watercourse Depth:</b> 0.15 m</p> <p><b>Notes:</b> Watercourse surveyed approximately 130m upstream of proposed crossing point. Watercourse incised in bedrock and situated within channel up to 0.5 m high.</p> |
| Photograph Looking Upstream | |
| Photograph Looking Downstream | |

| Watercourse Crossing ID | WX13 |
|---|---|
| Proposed Crossing Type<br>Likely Required CAR Authorisation | <p>Culvert<br/>Registration</p> |

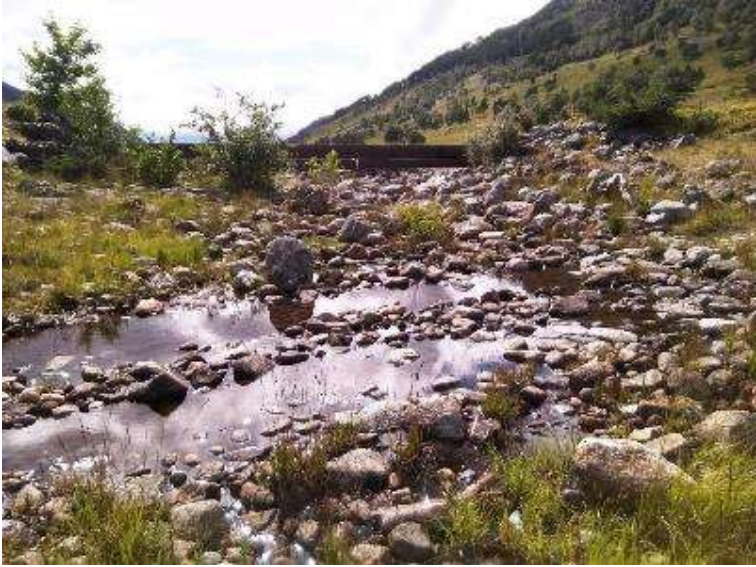
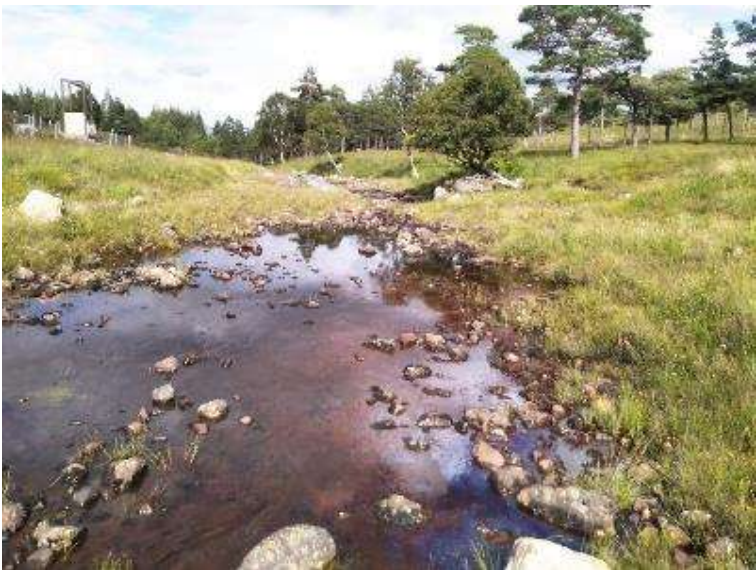
| Watercourse Crossing ID | WX14 |

| Watercourse Crossing ID | WX14 |
|---|---|
| Watercourse Crossing Details | <p><b>NGR:</b> NN 50266 85942</p> <p><b>Status:</b> New</p> <p><b>Watercourse Width:</b> 2 m</p> <p><b>Watercourse Depth:</b> 0.1 m</p> <p><b>Notes:</b> Surveyed approximately 230 m upstream of the proposed crossing.</p> |
| Photograph Looking Upstream | |
| Photograph Looking Downstream | |

| Watercourse Crossing ID | WX14 |
|---|---|
| Proposed Crossing Type<br>Likely Required CAR<br>Authorisation | <p>Open span bridge<br/>Licence</p> |

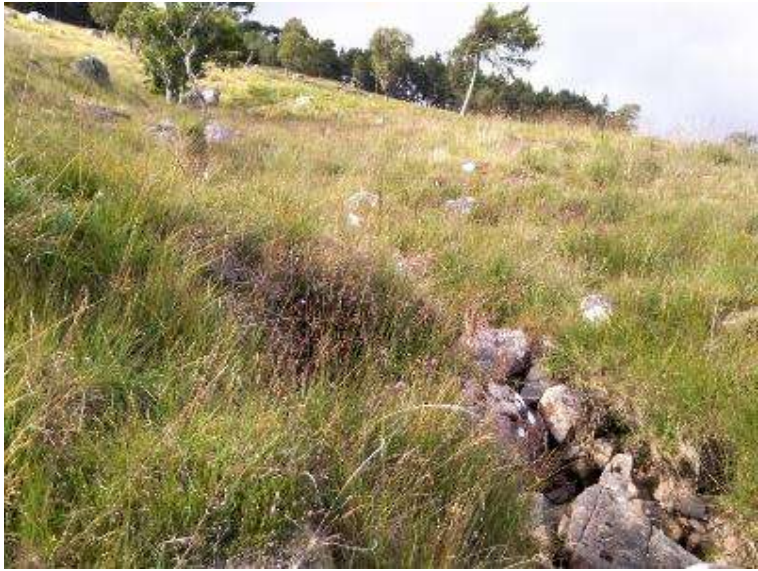
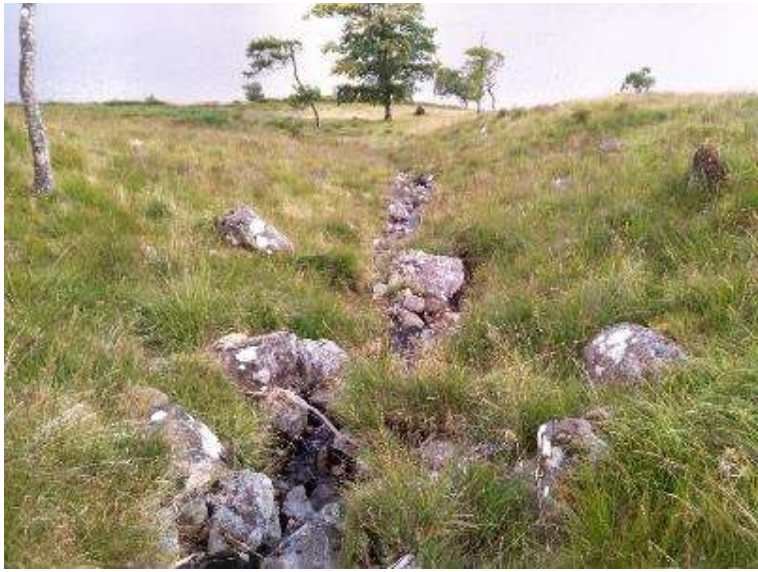
| Watercourse Crossing ID | WX15 |

| Watercourse Crossing ID | WX15 |
|---|---|
| Watercourse Crossing Details | <p><b>NGR:</b> NN 49155 84751</p> <p><b>Status:</b> New</p> <p><b>Watercourse Width:</b> 0.3 m</p> <p><b>Watercourse Depth:</b> 0.1 m</p> <p><b>Notes:</b> Situated within channel 0.8 m high</p> |
| Photograph Looking Upstream | |
| Photograph Looking Downstream | |

| Watercourse Crossing ID | WX15 |
|---|---|
| Proposed Crossing Type<br>Likely Required CAR<br>Authorisation | <p>Culvert<br/>Registration</p> |

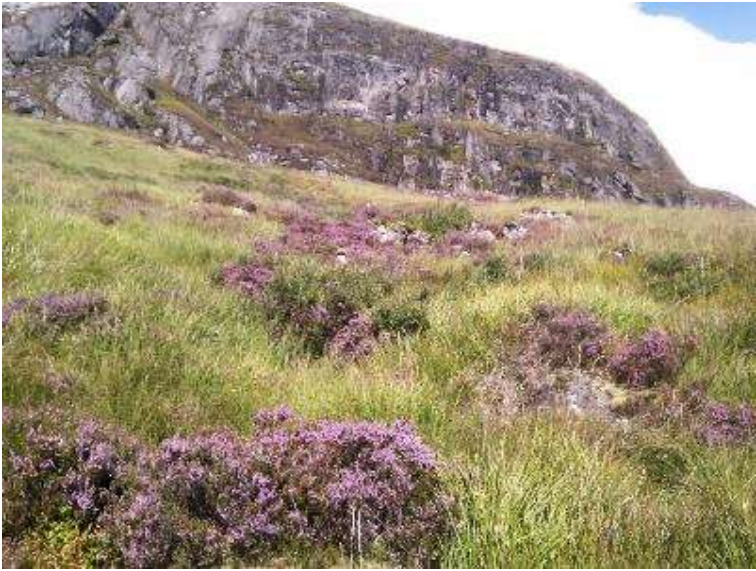
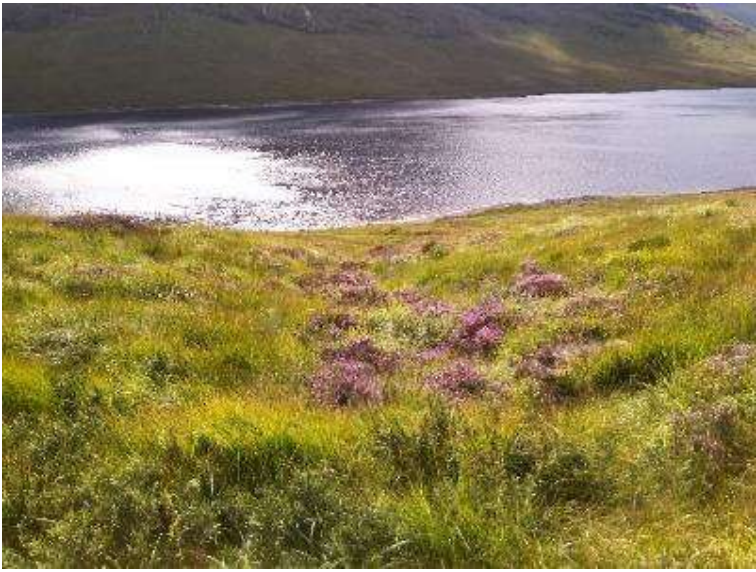
| Watercourse Crossing ID | WX16 |

| Watercourse Crossing ID | WX16 |
|---|---|
| Watercourse Crossing Details | <p><b>NGR:</b> NN 46967 82394</p> <p><b>Status:</b> New</p> <p><b>Watercourse Width:</b> 0.2 m</p> <p><b>Watercourse Depth:</b> 0.2 m</p> <p><b>Notes:</b> Situated within channel 0.4 m high. Heavily vegetated.</p> |
| Photograph Looking Upstream | |
| Photograph Looking Downstream | |

| Watercourse Crossing ID | WX16 |
|---|---|
| Proposed Crossing Type<br>Likely Required CAR<br>Authorisation | <p>Culvert<br/>Registration</p> |

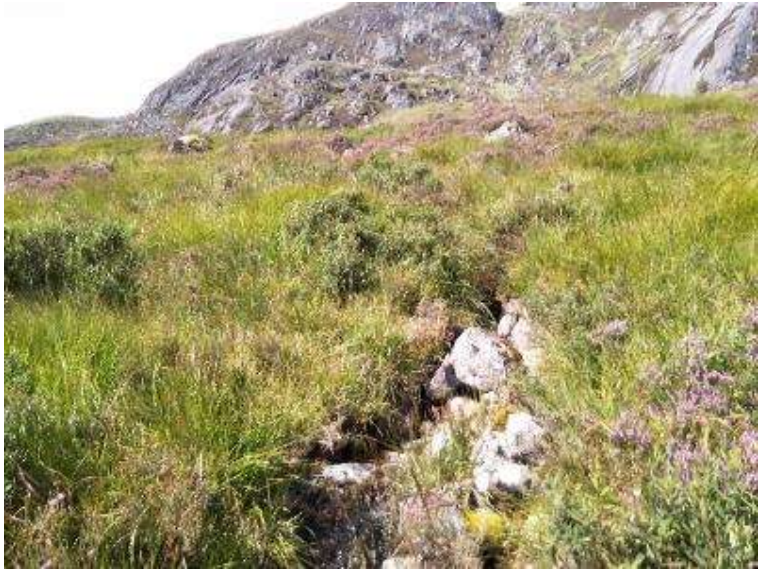
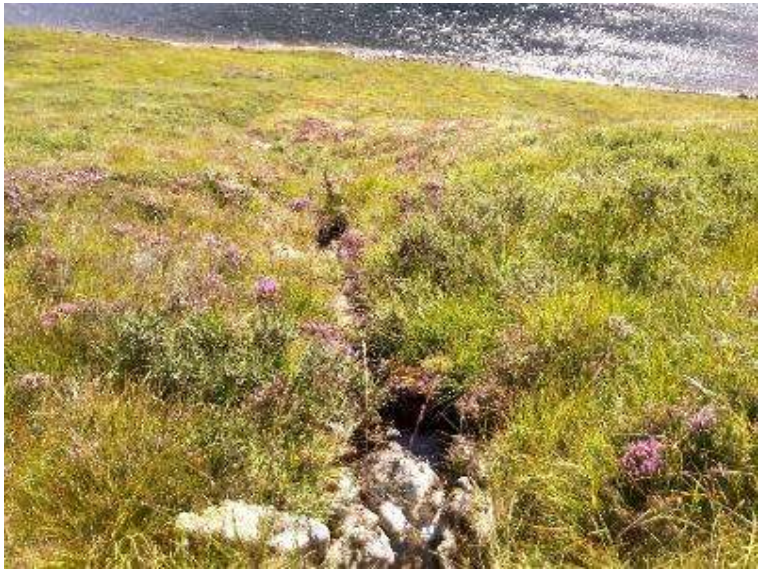
| Watercourse Crossing ID | WX17 |

| Watercourse Crossing ID | WX17 |
|---|---|
| Watercourse Crossing Details | <p><b>NGR:</b> NN 46897 82331</p> <p><b>Status:</b> New</p> <p><b>Watercourse Width:</b> 0.5 m</p> <p><b>Watercourse Depth:</b> 0.1 m</p> <p><b>Notes:</b> Situated within channel approximately 0.7m deep.</p> |
| Photograph Looking Upstream | |
| Photograph Looking Downstream | |

| Watercourse Crossing ID | WX17 |
|---|---|
| Proposed Crossing Type<br>Likely Required CAR<br>Authorisation | <p>Culvert<br/>Registration</p> |

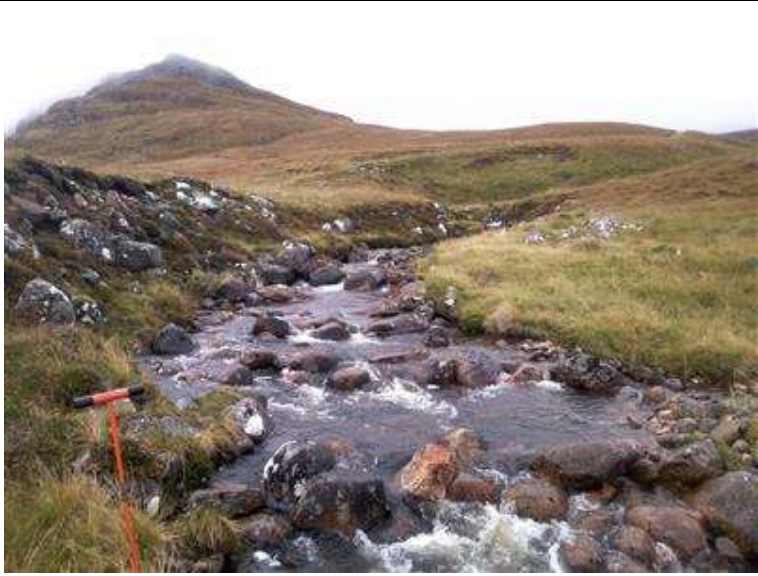
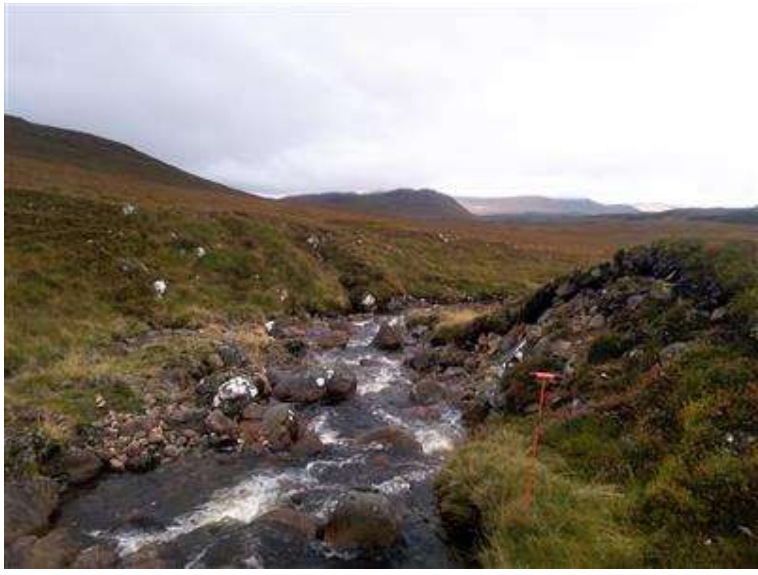
| Watercourse Crossing ID | WX18 |
|---|---|
| Watercourse Crossing Details | <p><b>NGR:</b> NN 46509 80679</p> <p><b>Status:</b> New</p> <p><b>Watercourse Width:</b> 5 - 10 m</p> <p><b>Watercourse Depth:</b> 0.3 m</p> <p><b>Notes:</b> Watercourse situated within wider channel approximately 2 m high. Surveyed approximately 50 m upstream of proposed crossing.</p> |
| Photograph Looking Upstream | |
| Photograph Looking Downstream | |

| Watercourse Crossing ID | WX18 |
|---|---|
| Proposed Crossing Type<br>Likely Required CAR<br>Authorisation | At location of proposed aqueduct. |

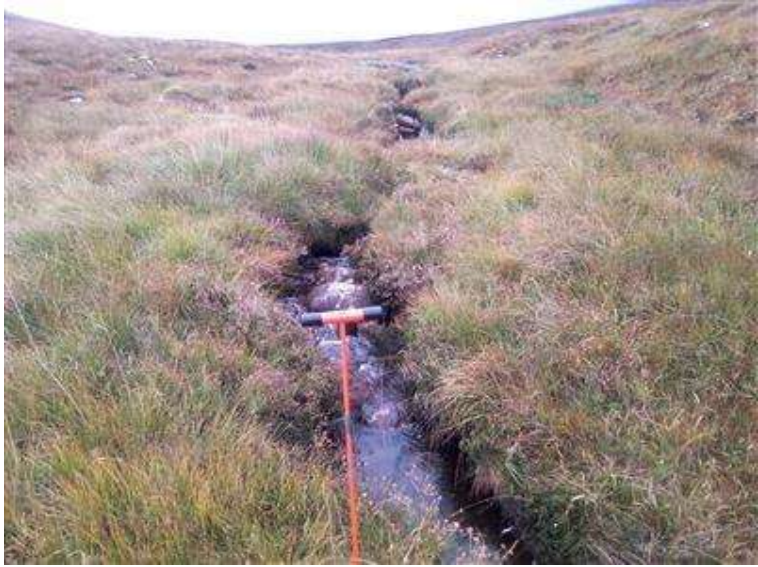
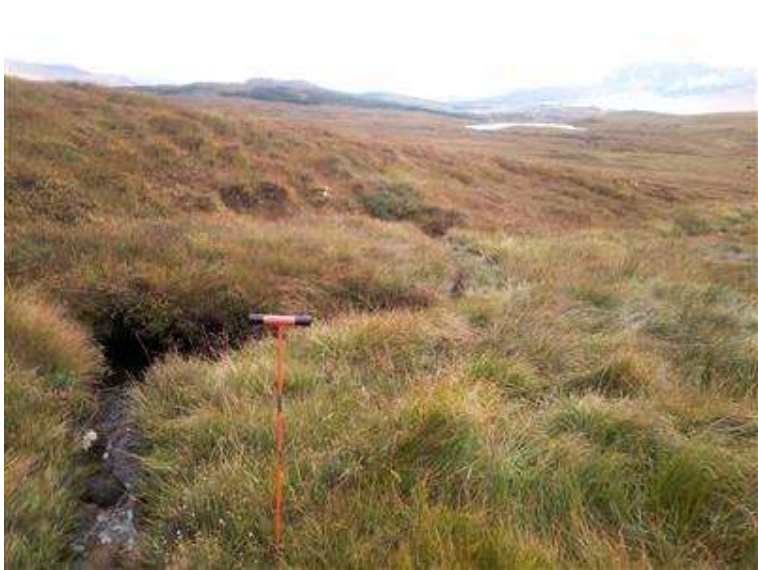
| Watercourse Crossing ID | WX19 |

| Watercourse Crossing ID | WX19 |
|---|---|
| Watercourse Crossing Details | <p><b>NGR:</b> NN 46407 80541</p> <p><b>Status:</b> New</p> <p><b>Watercourse Width:</b> 1 m</p> <p><b>Watercourse Depth:</b> 0.2 m</p> <p><b>Notes:</b> Surveyed approximately 100 m upstream of proposed crossing.</p> |
| Photograph Looking Upstream | |
| Photograph Looking Downstream | |

| Watercourse Crossing ID | WX19 |
|---|---|
| Proposed Crossing Type<br>Likely Required CAR<br>Authorisation | At location of proposed aqueduct. |

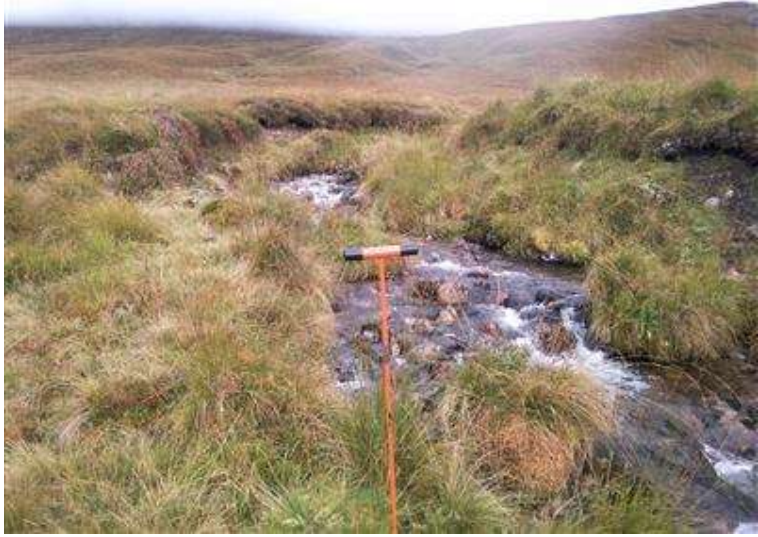
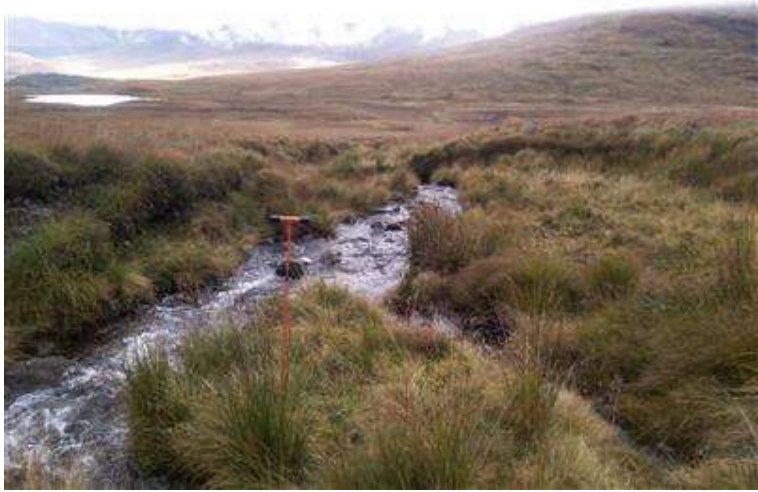
| Watercourse Crossing ID | WX20 |
|---|---|
| Watercourse Crossing Details | <p><b>NGR:</b> NN 46193 80333</p> <p><b>Status:</b> New</p> <p><b>Watercourse Width:</b> 2.5 m</p> <p><b>Watercourse Depth:</b> 0.2 m</p> <p><b>Notes:</b> Watercourse situated within channel approximately 1.5 m high. Surveyed approximately 180 m upstream of the proposed crossing.</p> |
| Photograph Looking Upstream | |
| Photograph Looking Downstream | |

| Watercourse Crossing ID | WX20 |
|---|---|
| Proposed Crossing Type<br>Likely Required CAR<br>Authorisation | At location of proposed aqueduct. |

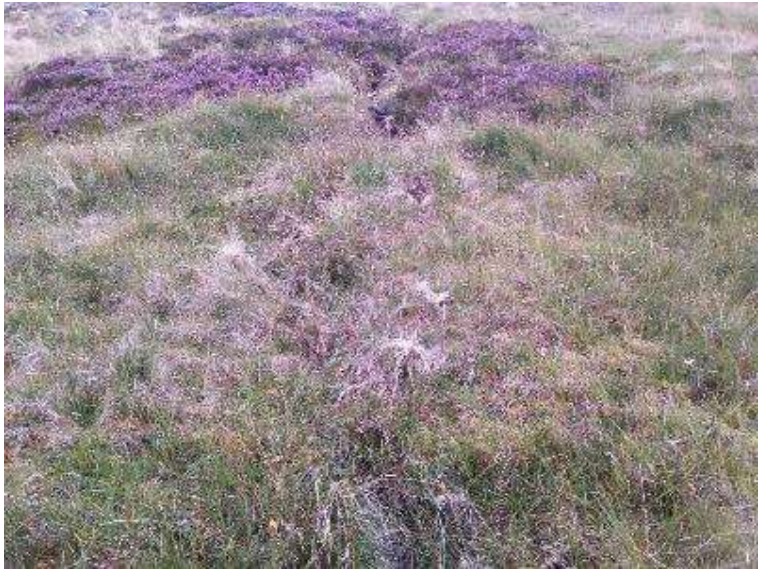
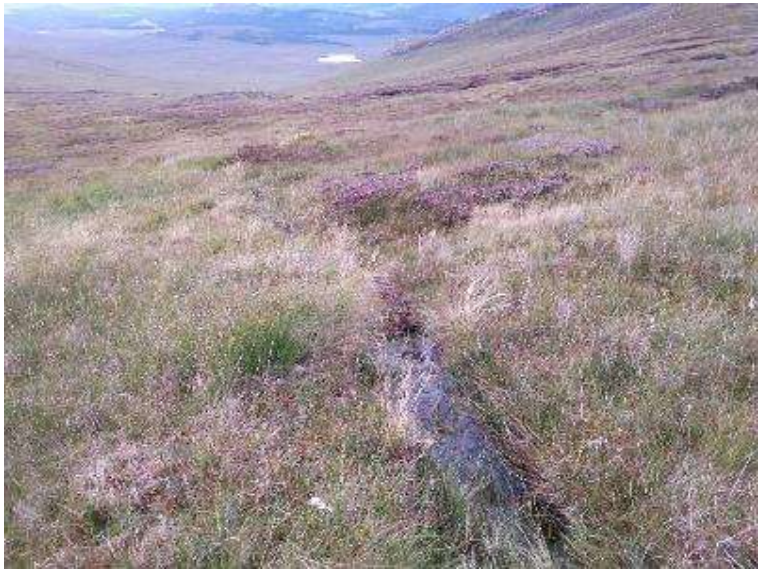
| Watercourse Crossing ID | WX21 |

| Watercourse Crossing ID | WX21 |
|---|---|
| Watercourse Crossing Details | <p><b>NGR:</b> NN 48679 80652</p> <p><b>Status:</b> New</p> <p><b>Watercourse Width:</b> 0.3 m</p> <p><b>Watercourse Depth:</b> 0.1 m</p> <p><b>Notes:</b> None</p> |
| Photograph Looking Upstream | |
| Photograph Looking Downstream | |

| Watercourse Crossing ID | WX21 |
|---|---|
| Proposed Crossing Type<br>Likely Required CAR<br>Authorisation | <p>Culvert<br/>Registration</p> |

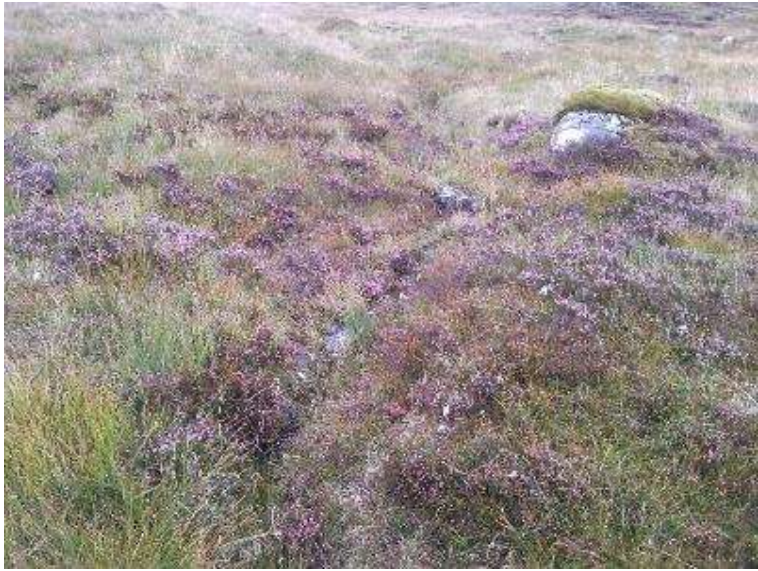
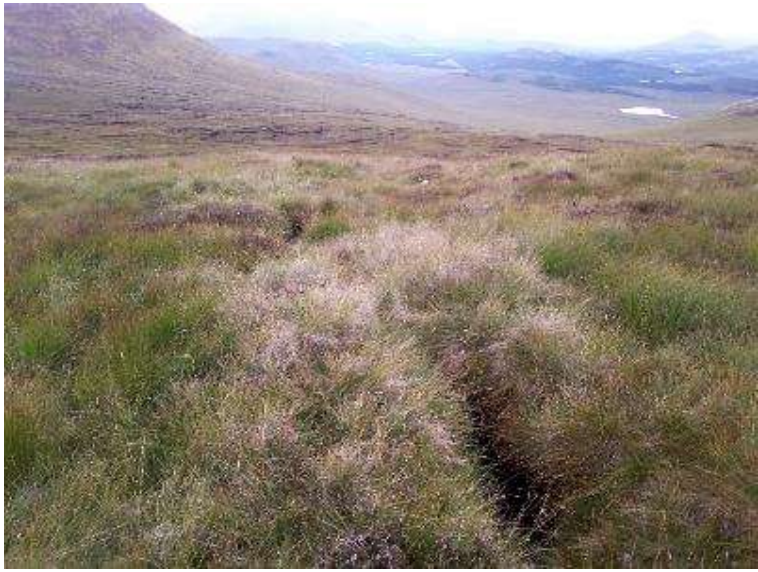
| Watercourse Crossing ID | WX22 |

| Watercourse Crossing ID | WX22 |
|---|---|
| Watercourse Crossing Details | <p><b>NGR:</b> NN 48724 80605</p> <p><b>Status:</b> New</p> <p><b>Watercourse Width:</b> 0.2 m</p> <p><b>Watercourse Depth:</b> 0.1 m</p> <p><b>Notes:</b> None</p> |
| Photograph Looking Upstream | |
| Photograph Looking Downstream | |

| Watercourse Crossing ID | WX22 |
|---|---|
| Proposed Crossing Type<br>Likely Required CAR<br>Authorisation | <p>Culvert<br/>Registration</p> |

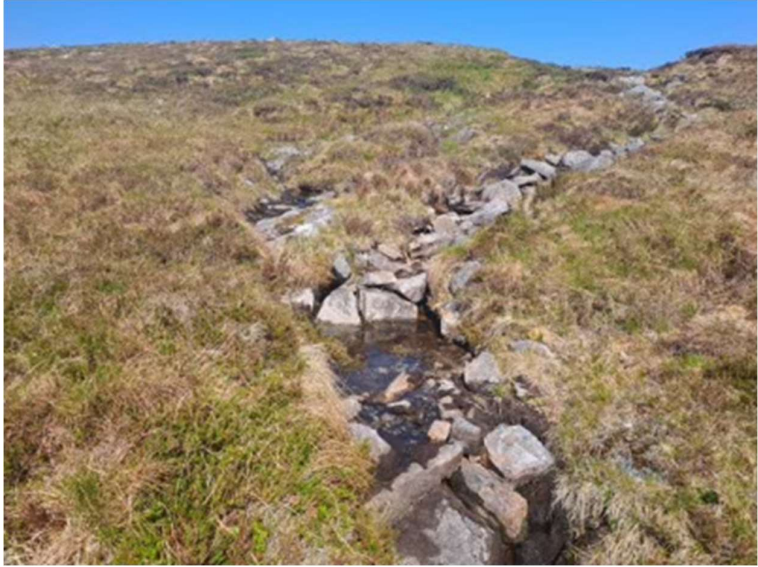
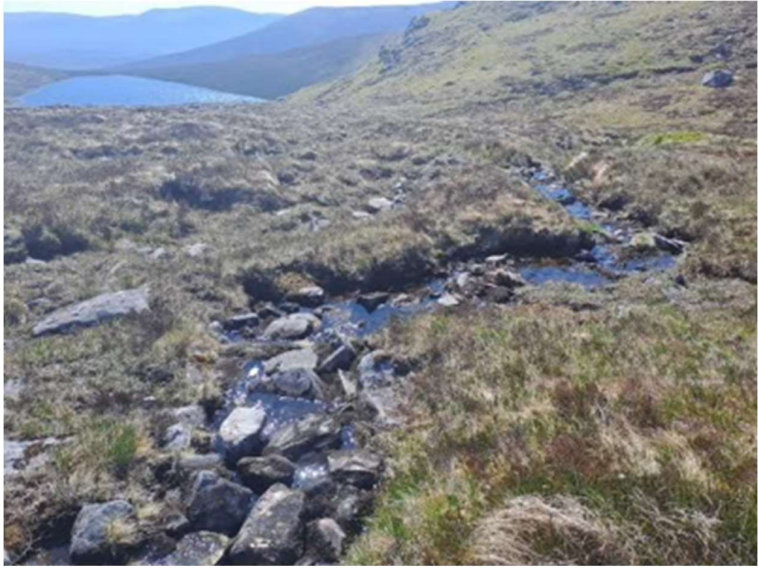
| Watercourse Crossing ID | WX23 |
|---|---|
| Watercourse Crossing Details | <p><b>NGR:</b> NN 49126 80025</p> <p><b>Status:</b> New</p> <p><b>Watercourse Width:</b> 0.8 m</p> <p><b>Watercourse Depth:</b> 0.1 m</p> <p><b>Notes:</b> Watercourse surveyed approximately 100 m upstream of the proposed crossing.</p> |
| Photograph Looking Upstream | |
| Photograph Looking Downstream | |

| Watercourse Crossing ID | WX23 |
|---|---|
| Proposed Crossing Type<br>Likely Required CAR<br>Authorisation | <p>Bottomless arch culvert.<br/>Registration</p> |

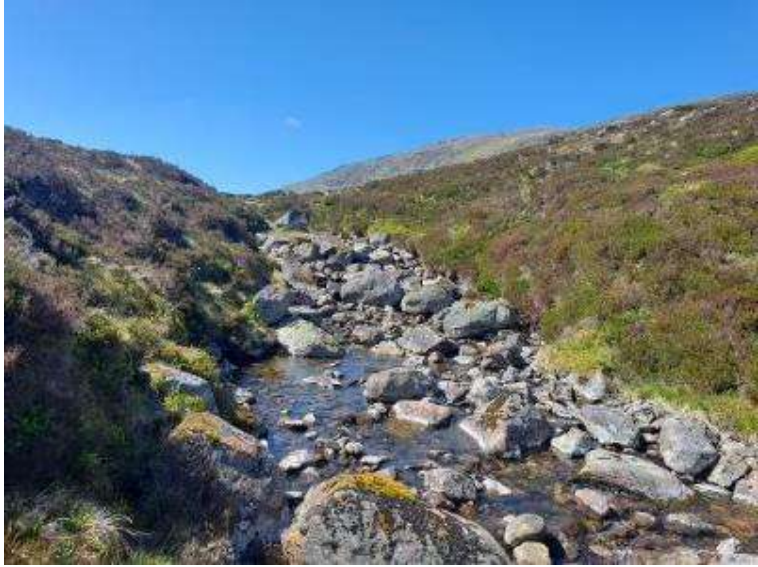
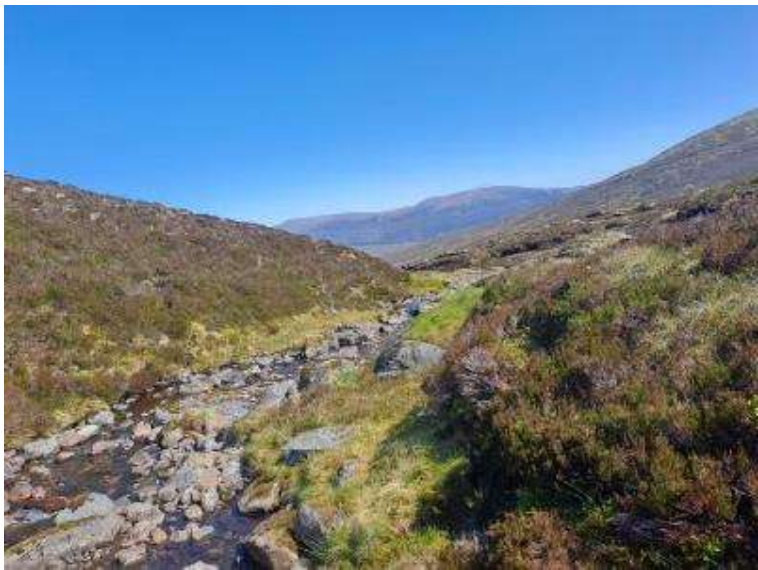
| Watercourse Crossing ID | WX24 |
|---|---|
| Watercourse Crossing Details | <p><b>NGR:</b> NN 50779 79258</p> <p><b>Status:</b> New</p> <p><b>Watercourse Width:</b> 4 m</p> <p><b>Watercourse Depth:</b> 0.2 m</p> <p><b>Notes:</b> Watercourse situated within a wider channel which is approximately 3 to 8 m high.</p> |
| Photograph Looking Upstream | |
| Photograph Looking Downstream | |

| Watercourse Crossing ID | WX24 |
|---|---|
| Proposed Crossing Type<br>Likely Required CAR<br>Authorisation | Downstream of the proposed Loch a Bhealaich Leamhain dam. |
